# Home Inspection Report

Street number, Lafayette, IN 47907

Friday January 1, 2021

The Way Professional Services, LLC. Home Inspections  
P.O. Box 381  
Brookston, IN 47923  
(765) 414-2361  
bill.lague@gmail.com

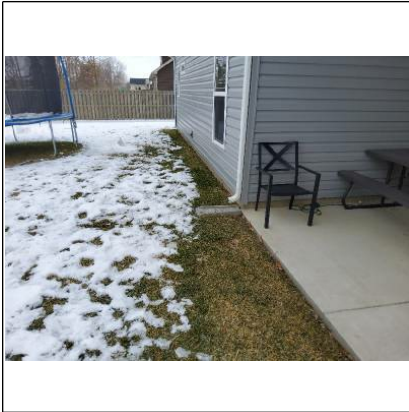
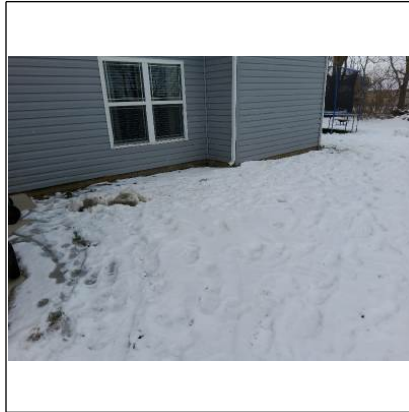
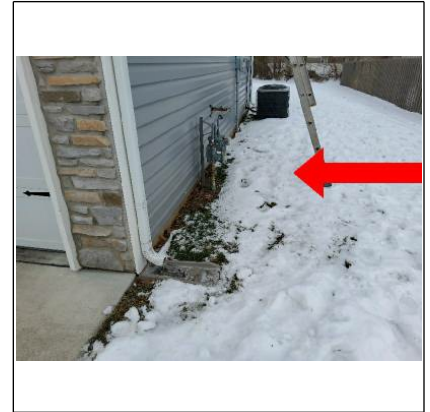
**Negative Grade** ☐ East ☒ West ☒ North ☐ South ☐ Satisfactory ☐ Recommend additional backfill  
☐ Recommend window wells/covers ☐ Trim back trees/shrubberies  
☐ Wood in contact with/improper clearance to soil

**Comments** The north side and west side ground grade is level to possibly negative. There is snow cover that limits the view, but it is recommended to adjust the slope to at least 6" in 10' drop away from foundation to move water away. Tile can be used or a soil removal to add a swale to obtain good drainage. Adding soil at the foundation is not recommended as this can get too close to the siding causing decay of wood sheathing behind the siding.

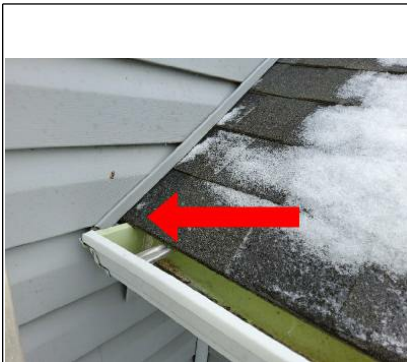
**Comments** Step flashing is not visible. The siding was installed to the roof shingles limiting visual confirmation of proper flashing. There should be at least 1" separation of siding to roof covering.  
Kick out flashing recommended north side roof to sidewall with gutter. Water penetration is possible at this location.  
Further evaluation and correction is recommend by a qualified and licensed roof contractor.

Missing kick out flashing.

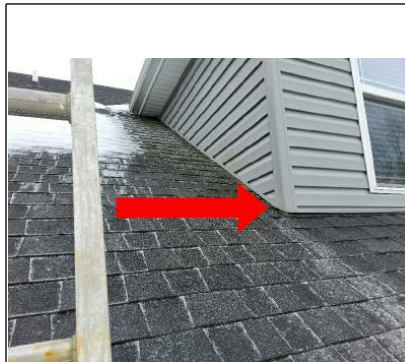
**Condition** ☐ Not Visible ☐ Satisfactory ☒ Marginal ☐ Poor ☐ Rusted ☐ Missing  
☐ Separated from chimney/roof ☐ Recommend Sealing Other: .

Can not verify step flashing existence.

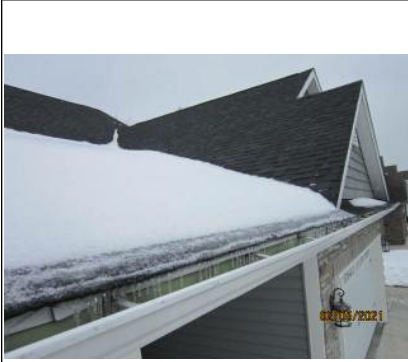
Valley covered by snow

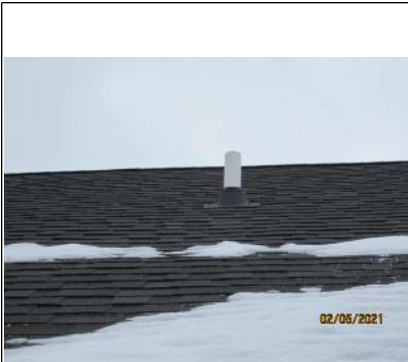
West side vent

**Comments** The 2 vents through the roof on the west side were visible from the ladder at the eave.  
 With binoculars the flashing looked to be in good shape.

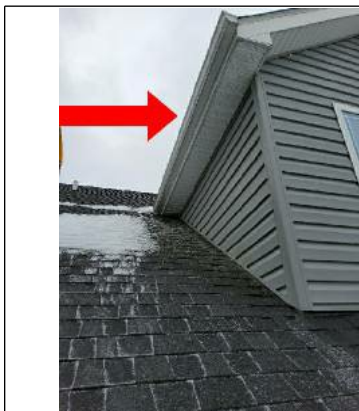
**Comments** Extensions of at least 5' recommended at all downspouts to improve water removal away from foundation.  
 The north dormer has gutters, but no downspout. This can cause water removal issues. Recommend either installing downspouts or removing gutters. Further evaluation and correction by a qualified & licensed contractor is recommended.

No downspout.

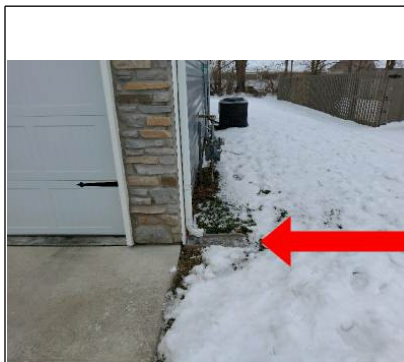
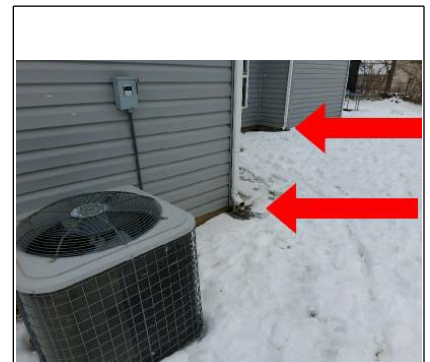
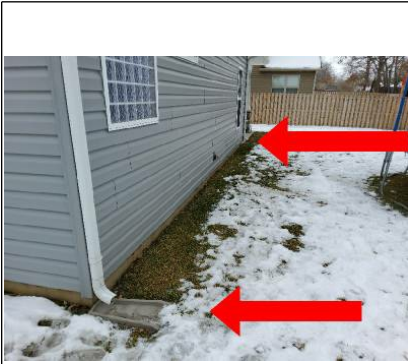
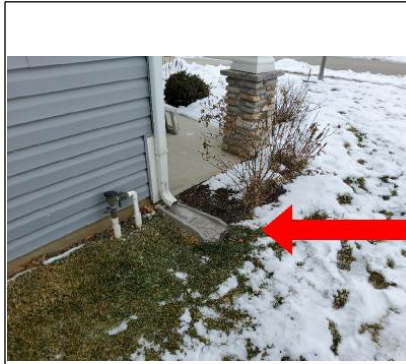
Extensions recommended.

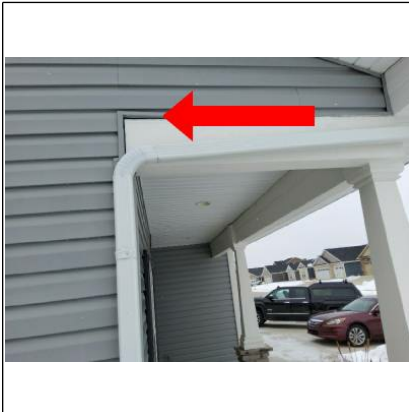
**Condition** ☐ Satisfactory ☒ Marginal ☐ Poor  
☒ Recommend around windows/doors/masonry ledges/corners/utility penetrations

**Comments** Recommend caulking to be applied to fiberboard trim along edges.

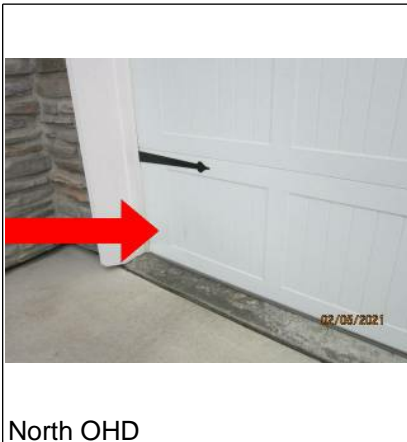
**Comments** North overhead door has a small dent in the exterior lower left corner.

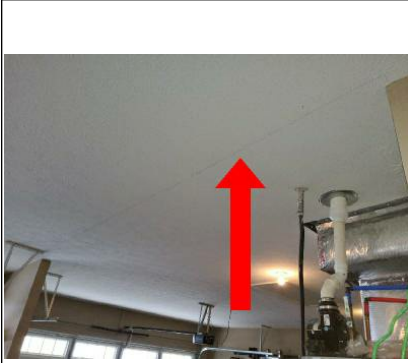
**Comments** There is a settling crack in the ceiling running length wise. Proper sealing repair is recommended. The door entering the garage from the interior is metal but should be self closing and the fire rating tag has been painted over.

Garage ceiling crack

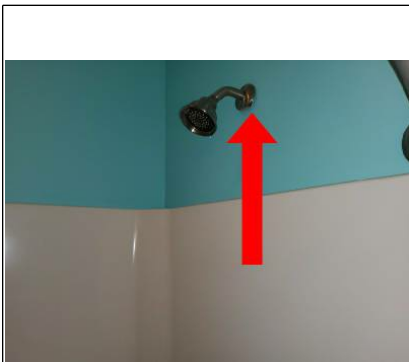
Upstairs, North.

**Comments** Recommend fixing seal around shower head stem entering wall.

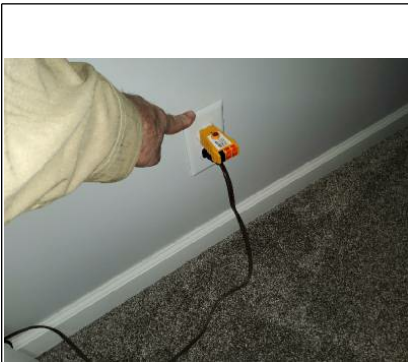
North wall

**Comments** Recommend further evaluation & repair of loose north wall outlet by a qualified electrical contractor.

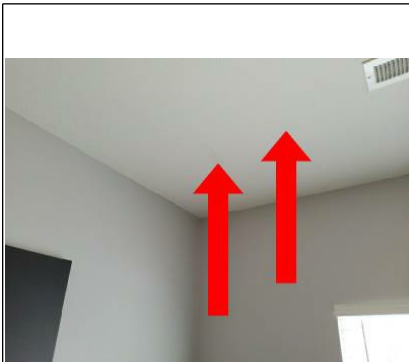
**Comments** There were two places of old repair in ceiling. No current issues observed during inspection.

Fixed areas of bedroom ceiling.

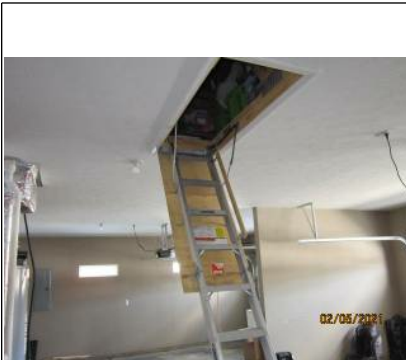
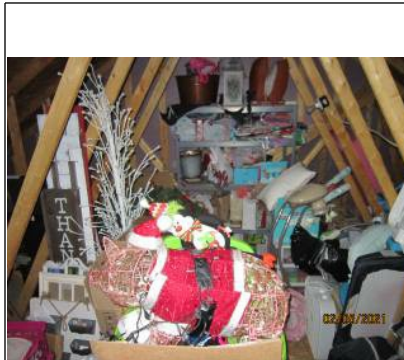
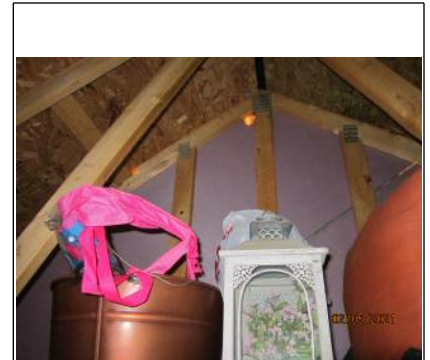
**Access** ☐ Stairs ☒ Pulldown ☒ Scuttlehole/Hatch ☐ No Access Other:  
 Access limited by: Entry into garage attic by pulldown. There were many items stored in area preventing me from getting full access. Entry into main house attic is upstairs in common area. Access limited by insulation covering truss joists. Unsafe to walk through.

**Comments** 8" depth insulation = approx. R28 value.  
 Recommend adding to achieve R49 as recommended for this area of the country.  
 Garage attic is somewhat compressed with OSB sheathing laid ontop of truss joists for storage. Trusses are not designed to carry weight. Items should no be stored in attic with trusses.  
 Viwing was limited in garage attic due to items stored in there.  
 Viewed main house attic from access hole upstairs in common area. Could not gain entry due to insulation covering truss beams. Not safe to enter without causing damage or disturbing insulation.

Garage attic area and where gable vent is covered by insulation sheet

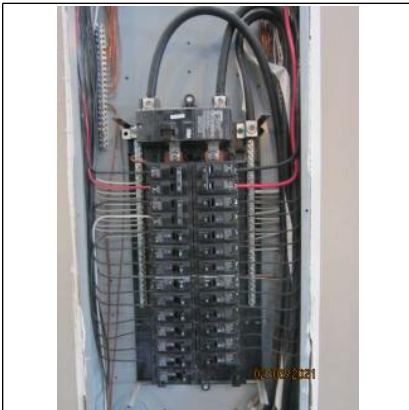
**Comments** The service panel in garage north wall is very dirty & dusty on and around the breakers. Recommend having cleaned by a qualified licensed electrician.

Main service panel garage

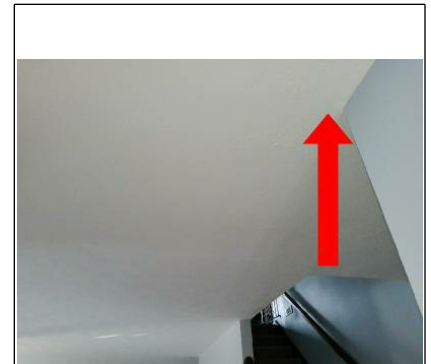
Living room southwest corner stain
